Norton Park Building, Edinburgh

– feedback for designers and clients

BEST PRACTICE
PROGRAMME

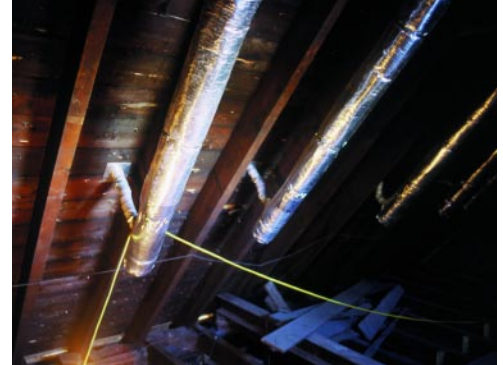
Figure 9 Solar heating system collector

Norton Park has a solar heating system that preheats ventilation air. The system works by drawing cold air from outside under south-facing roof slates. The slates are warmed by the sun and in turn they heat the incoming air.

Once the air has passed through the collector (figure 9) it is then conventionally heated (if necessary) before being distributed to the second floor offices.

A solar heating system devised by Edinburgh's Napier University makes use of air that is warmed by being drawn under the roof slates to preheat the air supply to the top floor of the building.
